From: Michelle Tucker <michelle.tucker@nexus-env.com>
Sent: Monday, April 8, 2024 11:00 AM
To: Michelle Barron
Cc: Carl Anderson; David Stephens
Subject: RE: [External] Crimson Bridge Public Hearing
Attachments: CBE Project Summary aerial 040824.pdf

Crimson Bridge Estates 1954

CRIMSON BRIDGE ESTATES
14533 RIVER ROAD
MIDDLETON, IDAHO

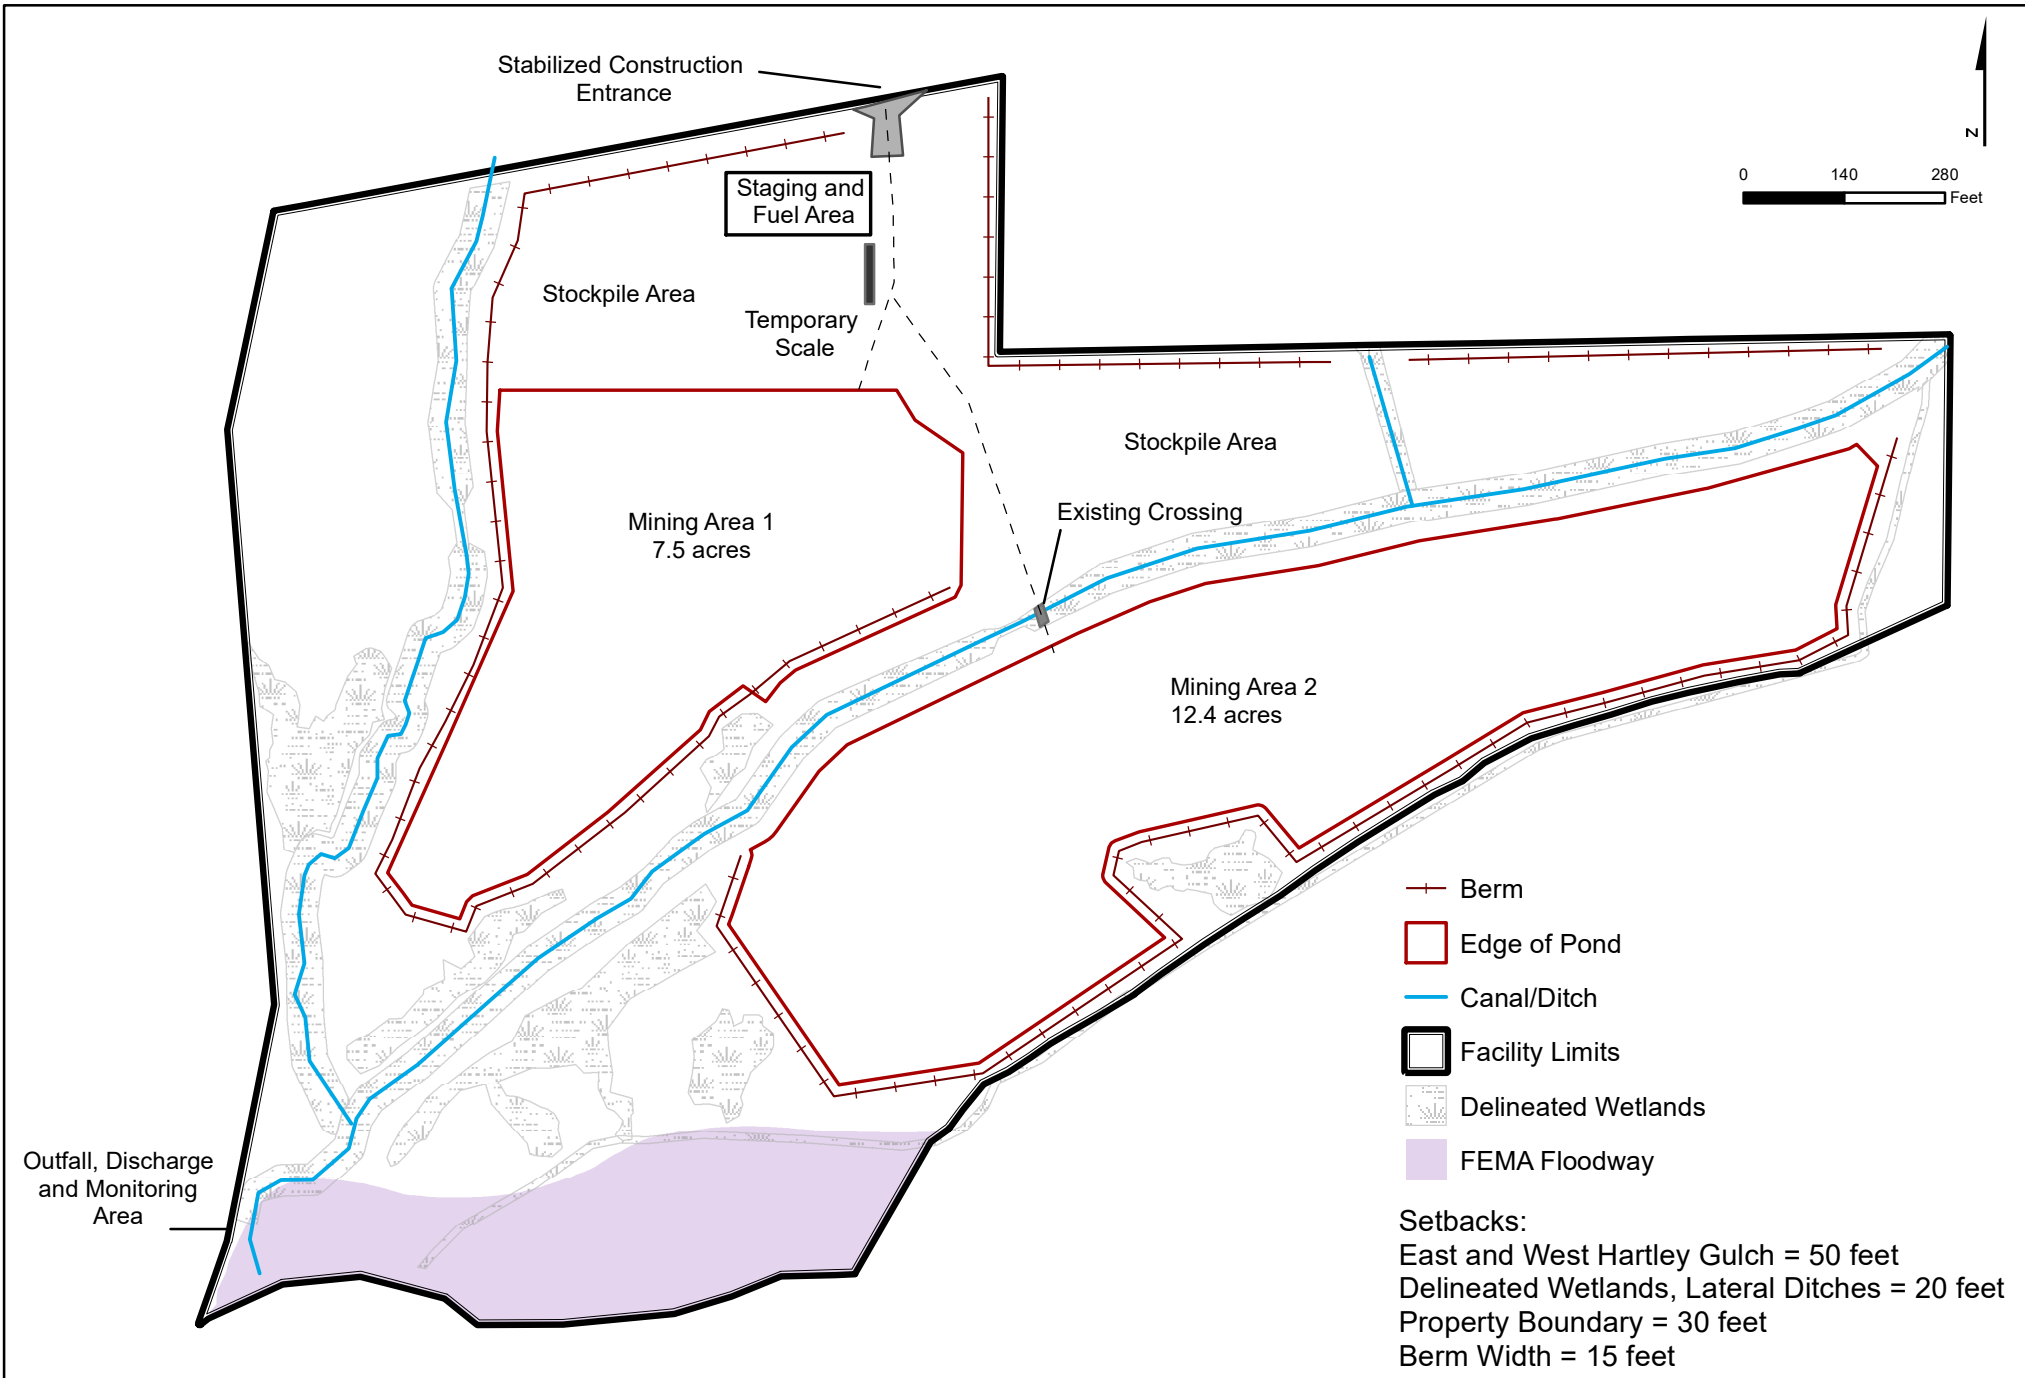
Notes: Temporary settling pond(s) will be constructed as necessary outside of the floodway, and delineated wetlands adjacent to the mining area for de-watering purposes. These temporary ponds will be discharged to one of two drainage ditches under IPDES permit.

1. **Revised comment letter from Caldwell.** We have worked with Caldwell on this and are in full agreement with the requested conditions in the City's letter.
2. **Revised project site plan.** The site plan has been revised to include additional details and mitigation to account for agency comments and to address the findings in the attached wetland delineation and sound study. The site

plan has been revised to avoid all wetland areas identified in the delineation. We have also provided additional berming and specific crushing locations on the site plan to comply with the recommended mitigation in the sound study.

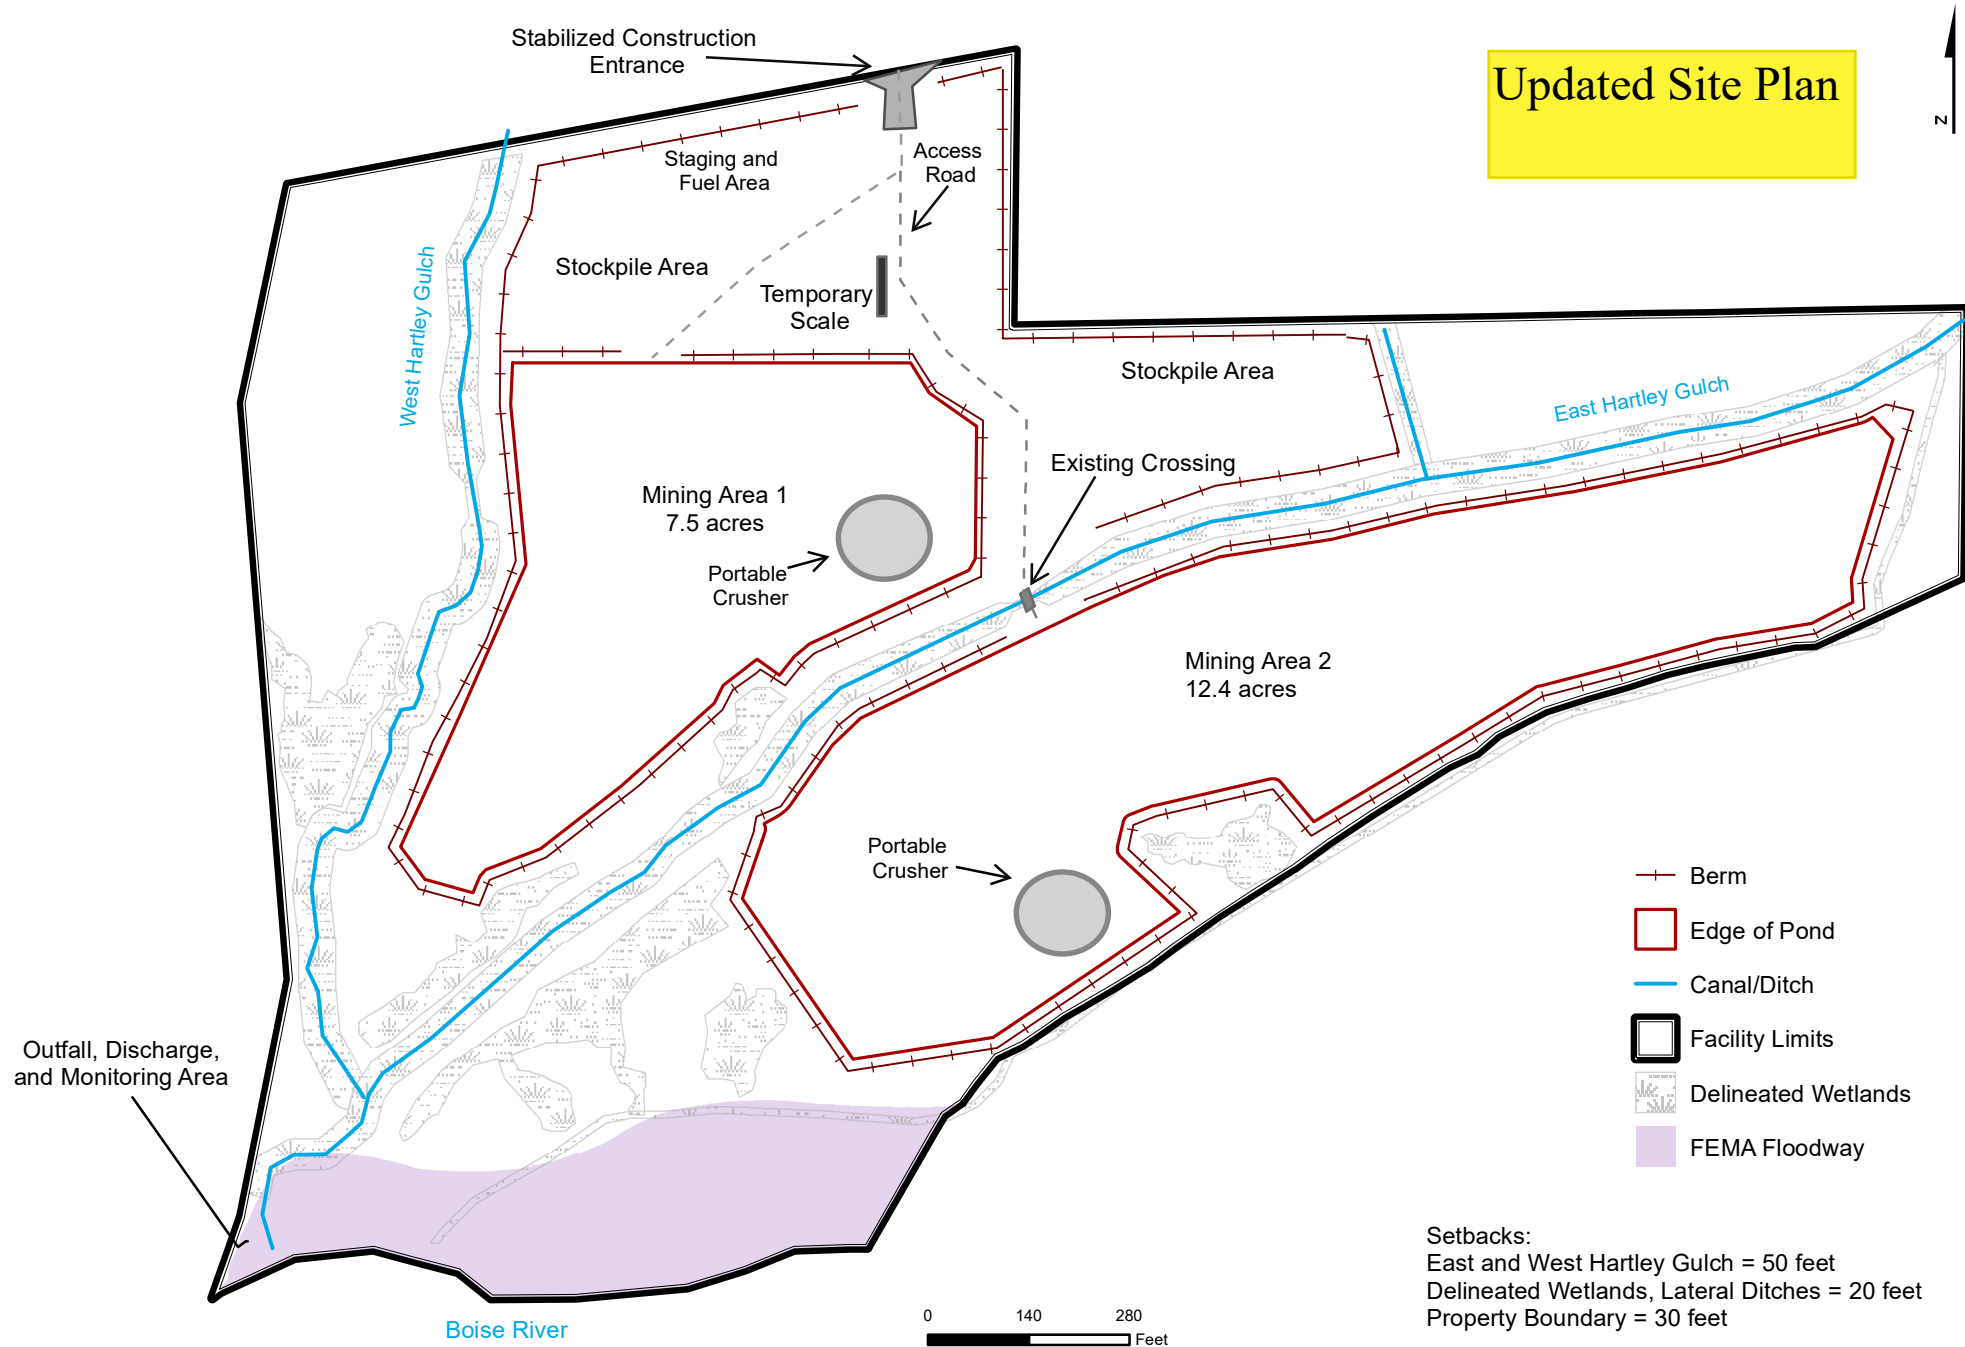
Updated Site Plan

Notes: Temporary settling pond(s) will be constructed as necessary outside of the floodway, and delineated wetlands adjacent to the mining area for de-watering purposes. These temporary ponds will be discharged to one of two drainage ditches under IPDES permit.

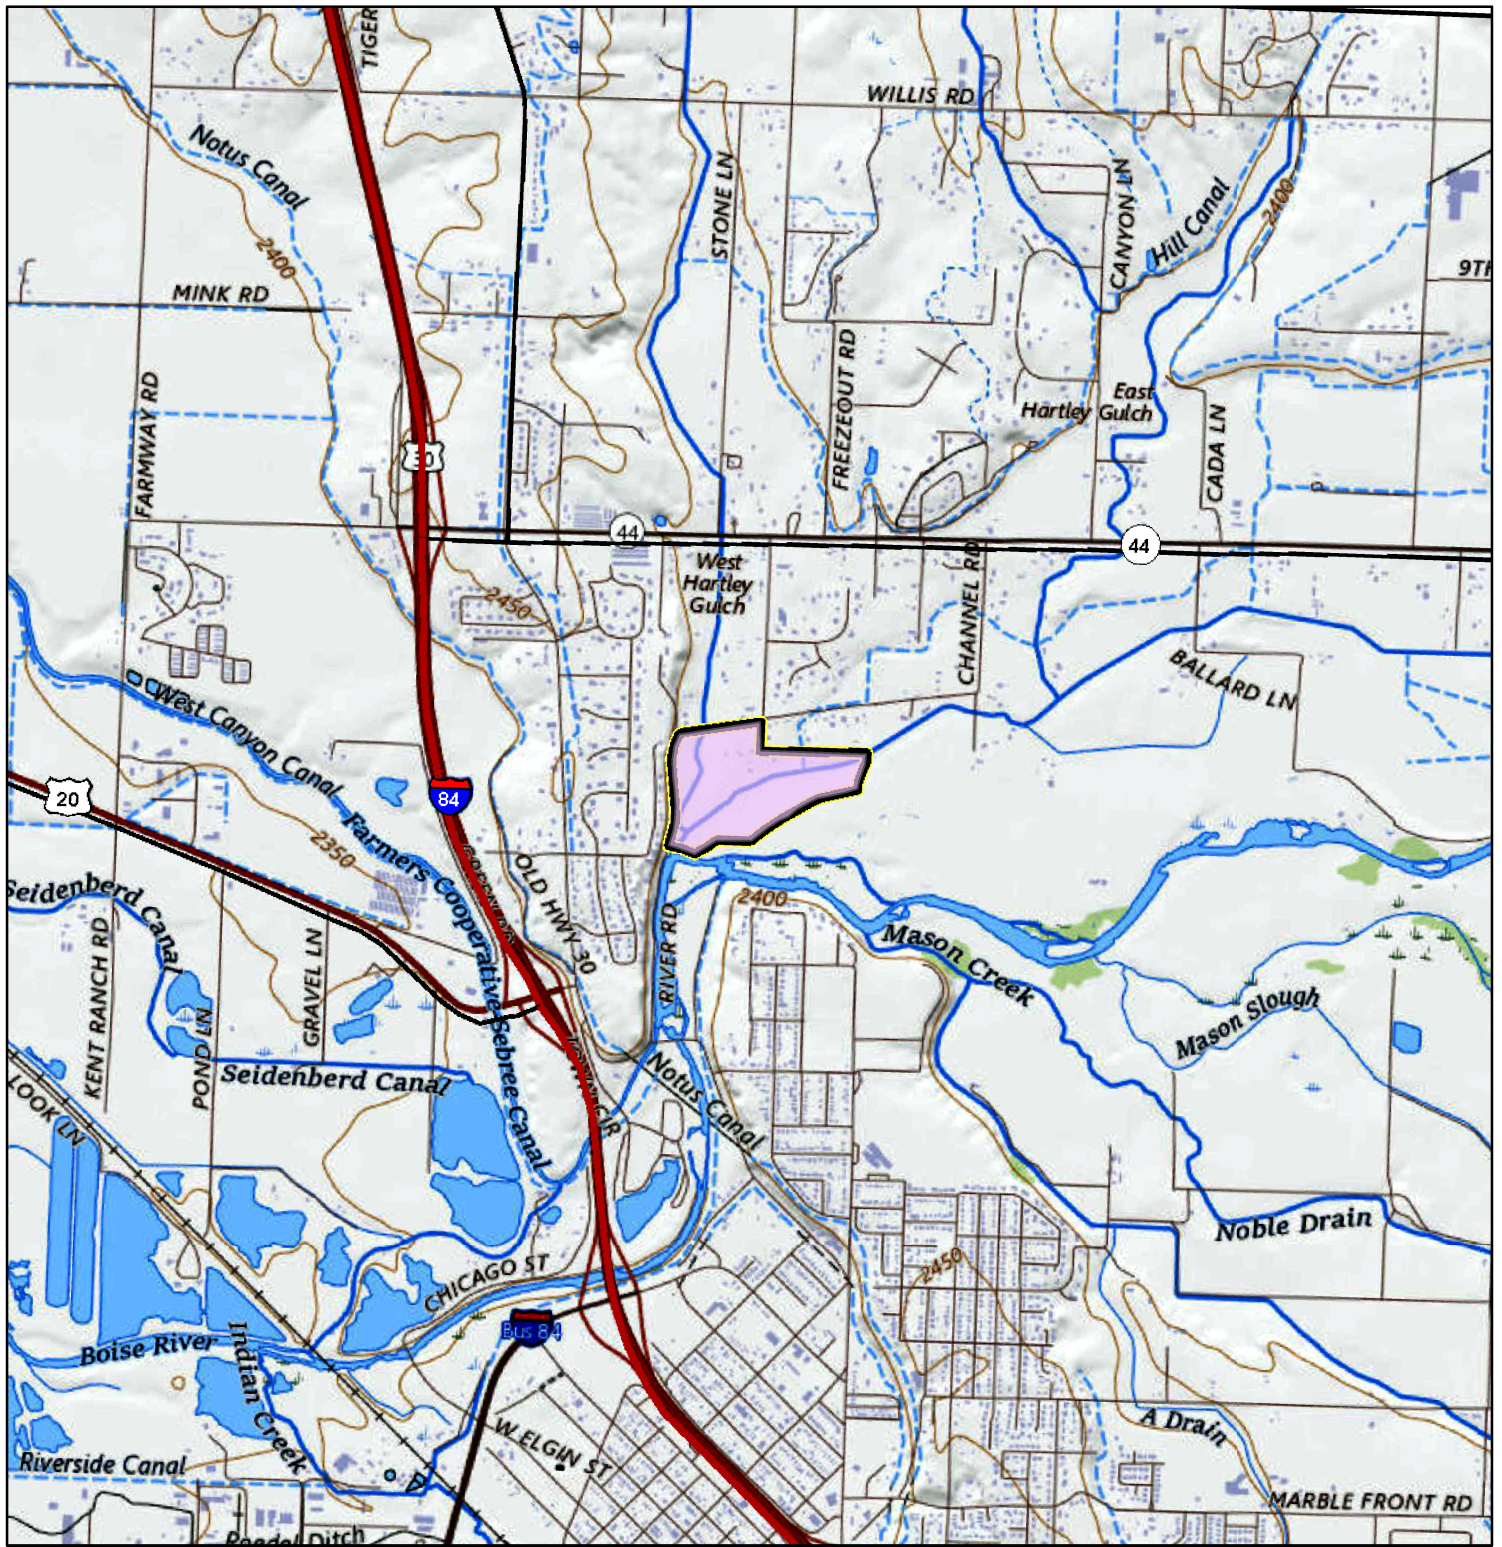
Subsurface Conditions. Based on information obtained from review of well driller reports (aka well logs) available from IDWR's online database, RMEA identified many wells in the vicinity of the Subject Property. For the purposes of this preliminary evaluation, RMEA confined its review to wells identified by IDWR to be within approximately 1/4 mile (approximately 1320 feet) of the outside footprints of the two pits. RMEA identified 70 wells located within this zone. The estimated locations of these wells are shown in Figure 2. Note that some well locations provided by IDWR represent multiple wells, which may not be at the exact locations shown in Figure 2. Also, locations of wells in Figure 2 are based on well locations shown on IDWR's website, which are not precise but rather approximations. A summary of selected relevant information about these wells, based on well log information, is provided in Table 1, with numbers shown for each well or group of wells in Figure 2 corresponding to numbers shown in Table 1. Well logs are also attached.

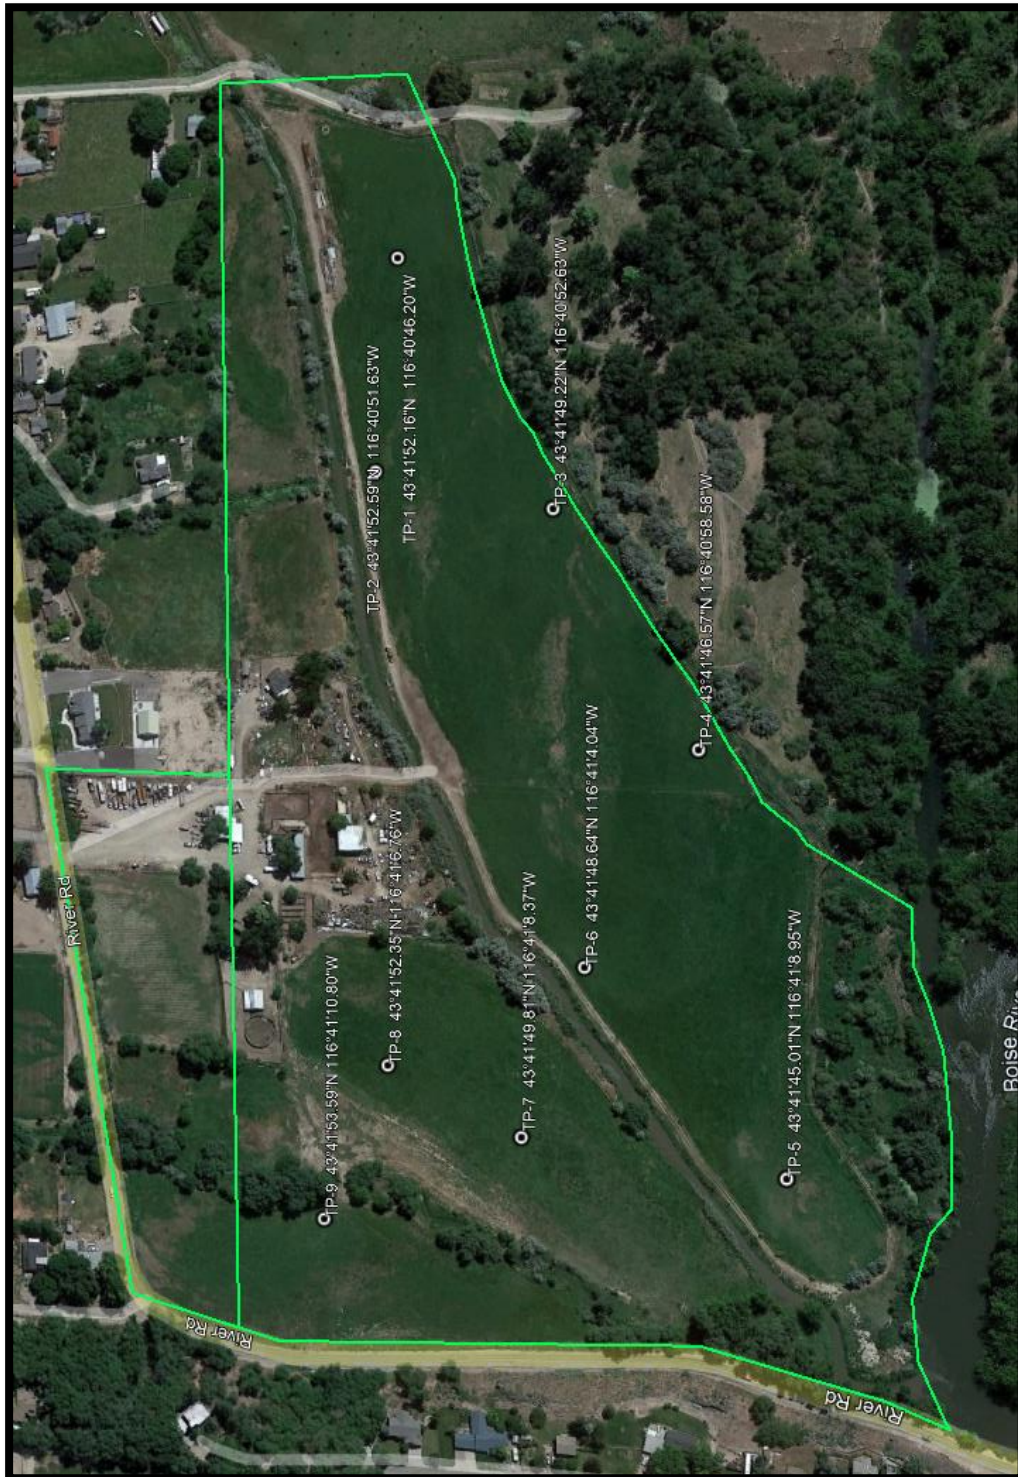
AERIAL PHOTO with test pit locations

SITE observed the excavation of nine test pits at locations intended to provide full coverage of the subject property. This investigation was performed on property located at 14533 River Road in Caldwell, Idaho. The property is just north of the Boise River and the City of Caldwell's Curtis Park. Nine rural properties that front Channel Road are along the north property boundary. The following information was obtained from the Canyon County Assessor's records utilizing landprodata.com

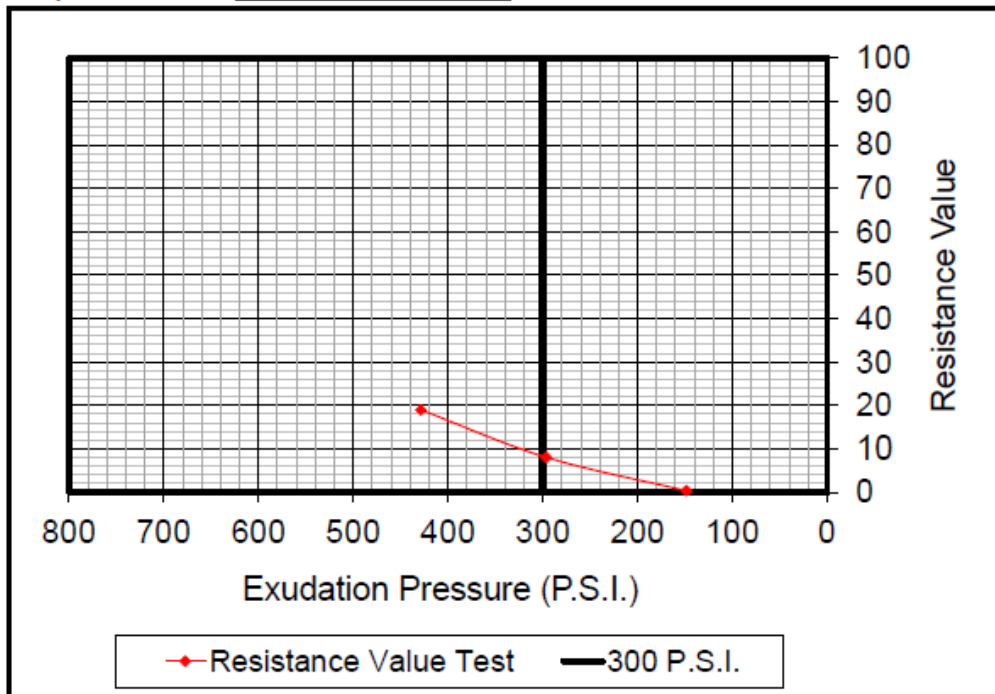
Specimen No.	1	2	3
Moisture Content (%)	17.5	18.7	20.1
Dry Density (PCF)	106.7	104.9	103.5
Resistance Value (R)	19	8	0
Exudation Pressure (PSI)	429	296	148
Expansion Pressure	95	48	0
As Received Moisture Content (%)	17.5

RESISTANCE VALUE AT 300 P.S.I. 8

A sample of the surface silt/sand was sent to a specialty soil lab for R-Value Testing. Based upon an R-Value result of R=8 and a traffic Index of TI=6, a pavement section of 2.5" / 4.0" /13.0" is recommended for all subdivision interior streets. Placement of granular structural fill in the subgrade of proposed roadways will reduce the needed pavement section. All materials and methods used for subdivision construction are to comply with ACCHD and / or ISPWC requirements.

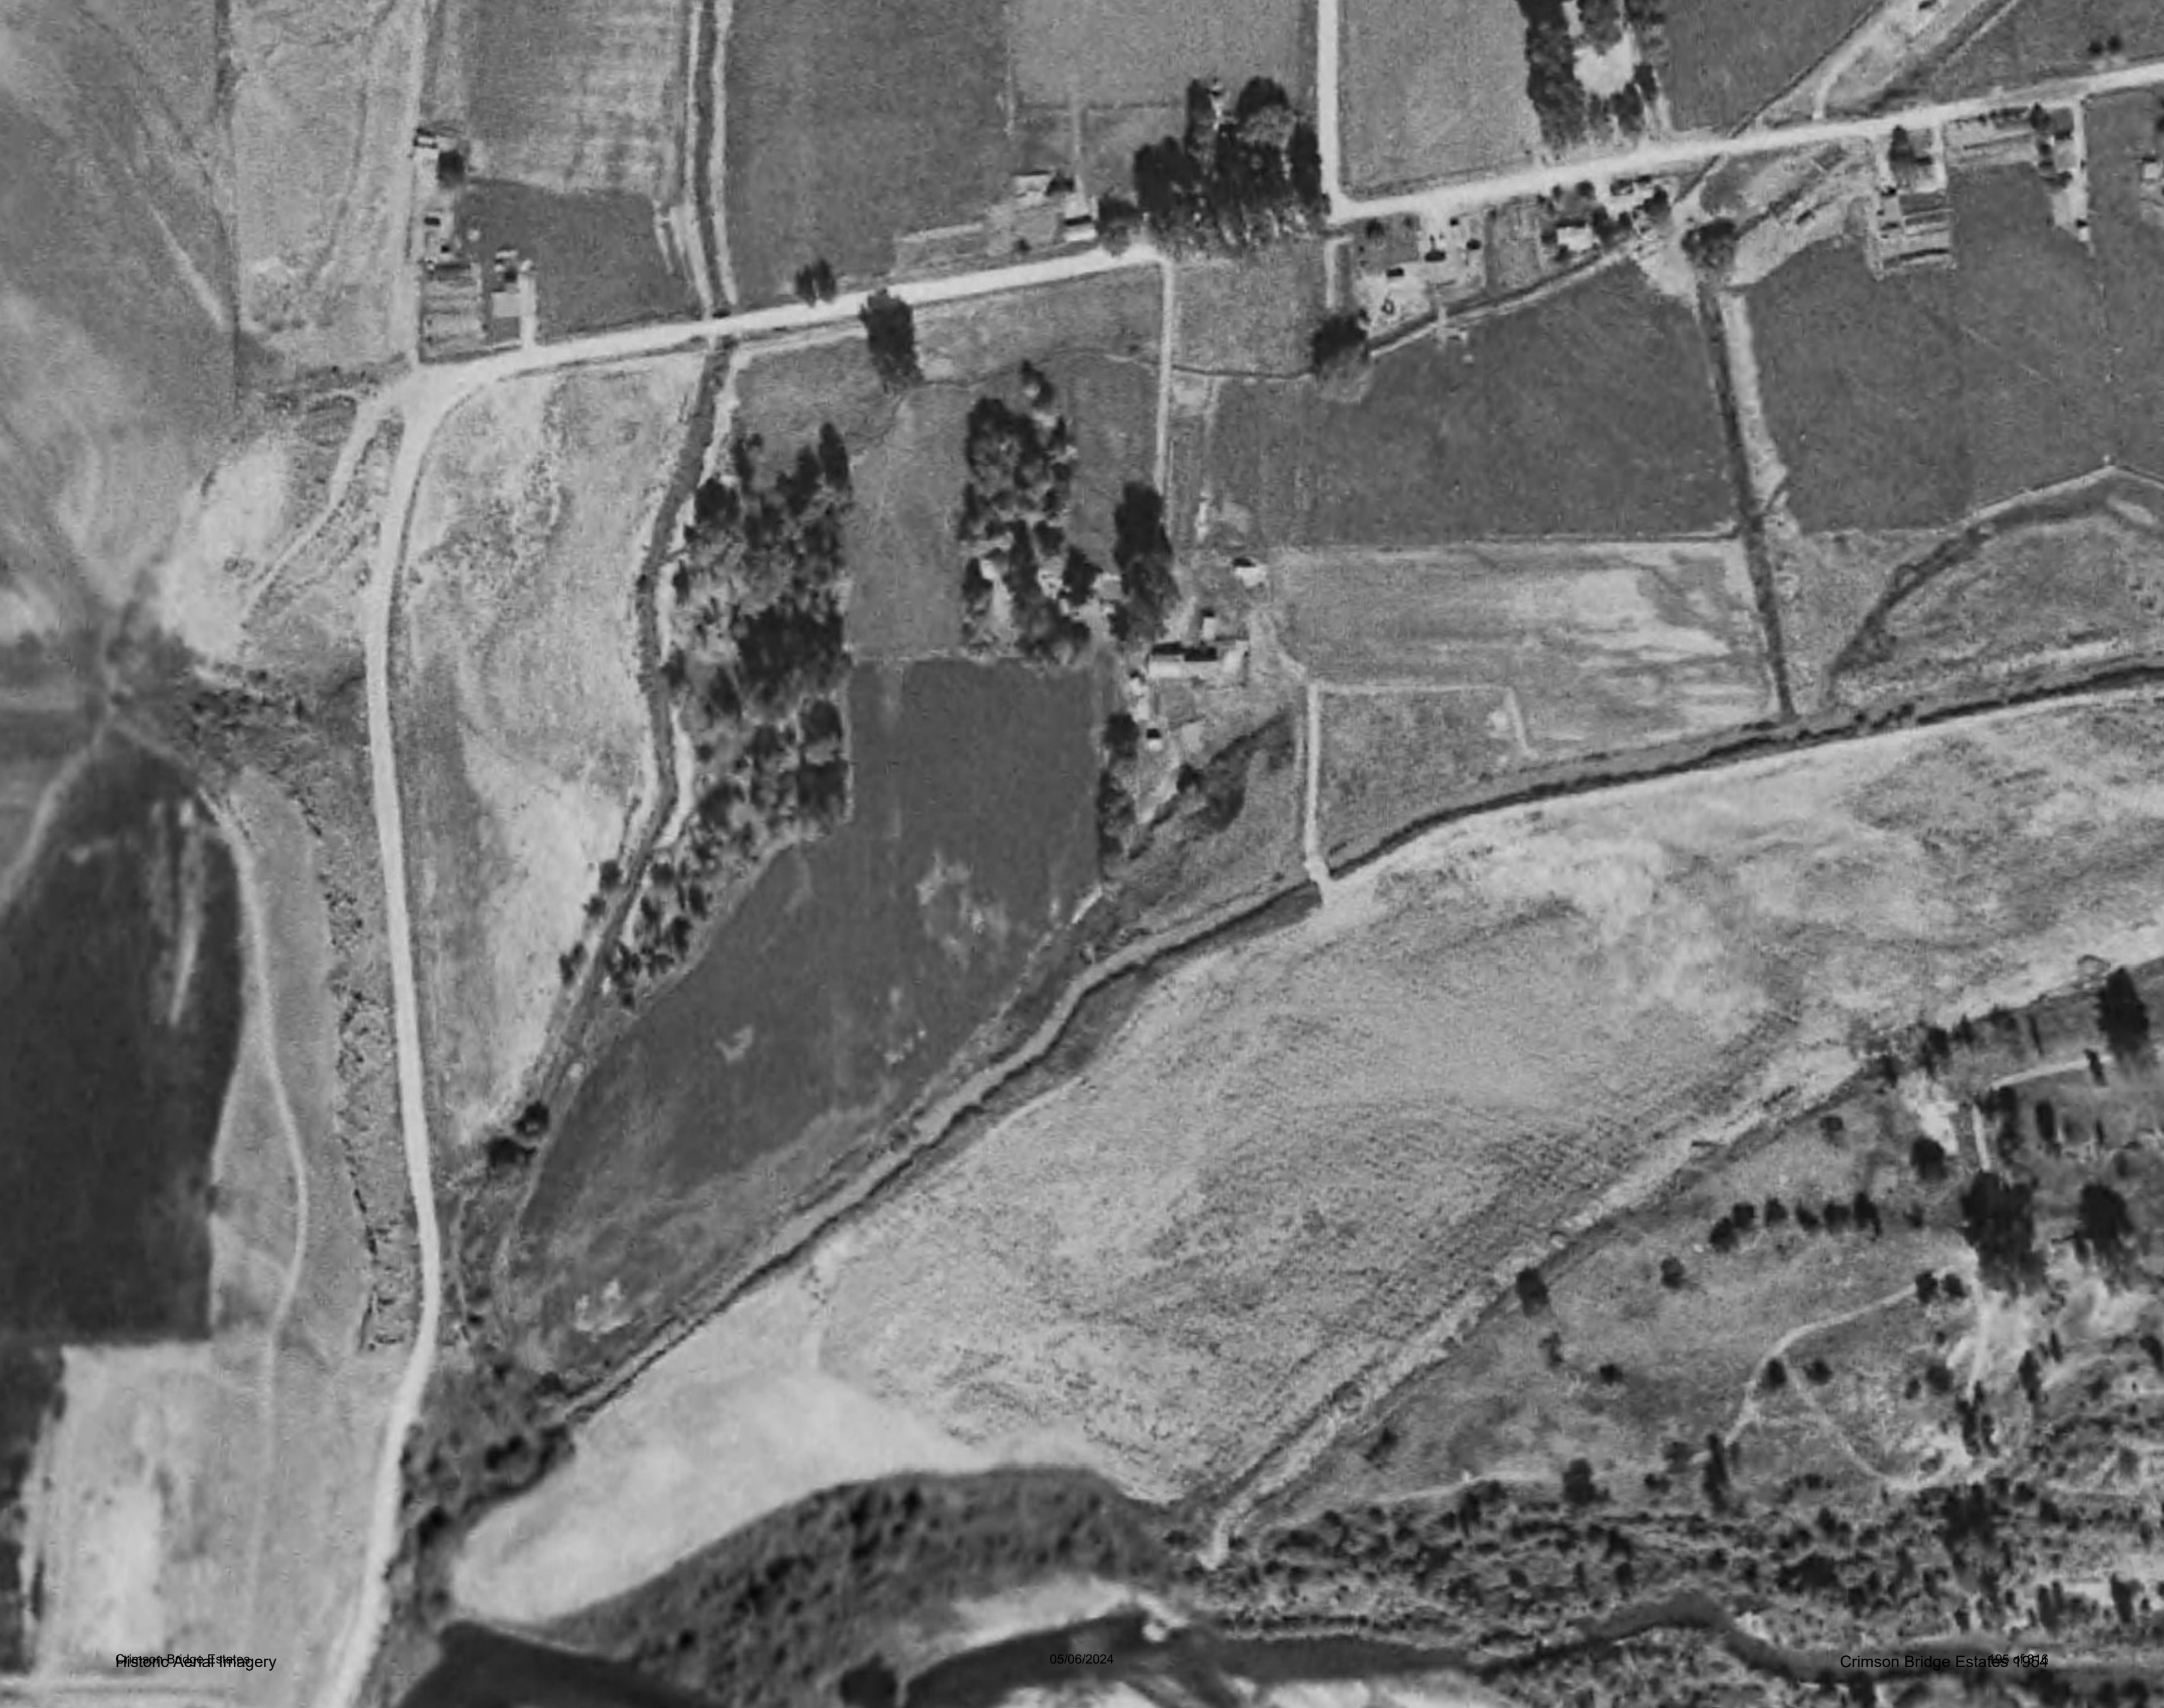
Figure 3
Data Points and Survey Tracks

Surveys included walking the site and determining the dominant vegetation in both wet and dry sites (**Appendix E, Figure 3**). If vegetative cover clearly indicated upland vegetation and lack of hydrology, no soil pits were dug. Wet areas that were not associated with a defined drainage or out-of-channel were evaluated with matched pairs of data points. At least one soil pit was established within the wetland boundary and one outside. The wetland boundary was delineated based on the surface expression of vegetation and hydrology, once hydric soils were confirmed, or additional test pits were dug, as necessary. Surveyors walked the boundaries of wetland areas with GPS units once their distinguishing characteristics, such as dominant vegetation and geographic position, were confirmed. Digital imagery was further considered for determining wetland boundaries once the three-parameter wetland criteria was established for each site.

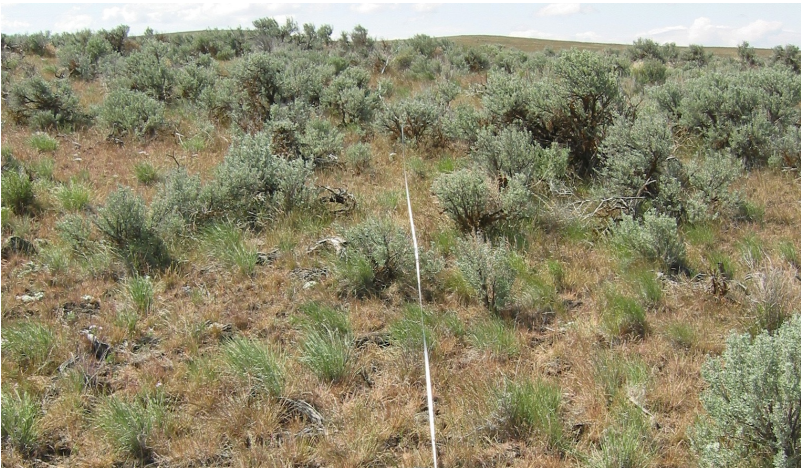
Figure 4. State 1

The HCPC has Wyoming big sagebrush in the overstory with bluebunch wheatgrass dominating the understory. Thurber’s needlegrass is the subdominant grass. Other significant species include Sandberg bluegrass, bottlebrush squirreltail, and arrowleaf balsamroot. There can be a variety of other grasses, forbs and shrubs in minor amounts. Natural fire frequency is 50-70 years.

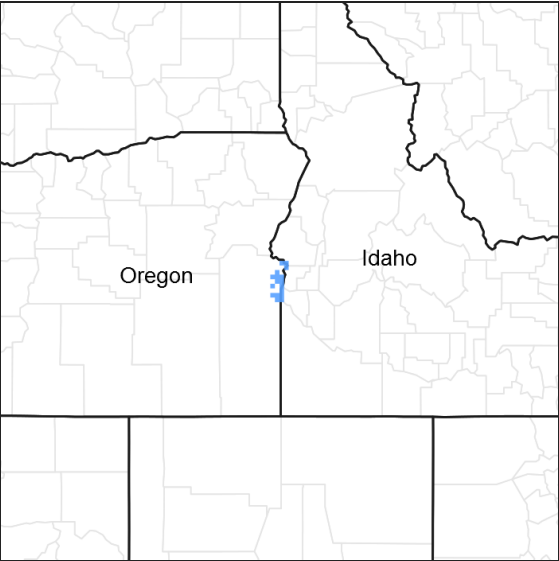
Figure 1. Mapped extent

Areas shown in blue indicate the maximum mapped extent of this ecological site. Other ecological sites likely occur within the highlighted areas. It is also possible for this ecological site to occur outside of highlighted areas if detailed soil survey has not been completed or recently updated.

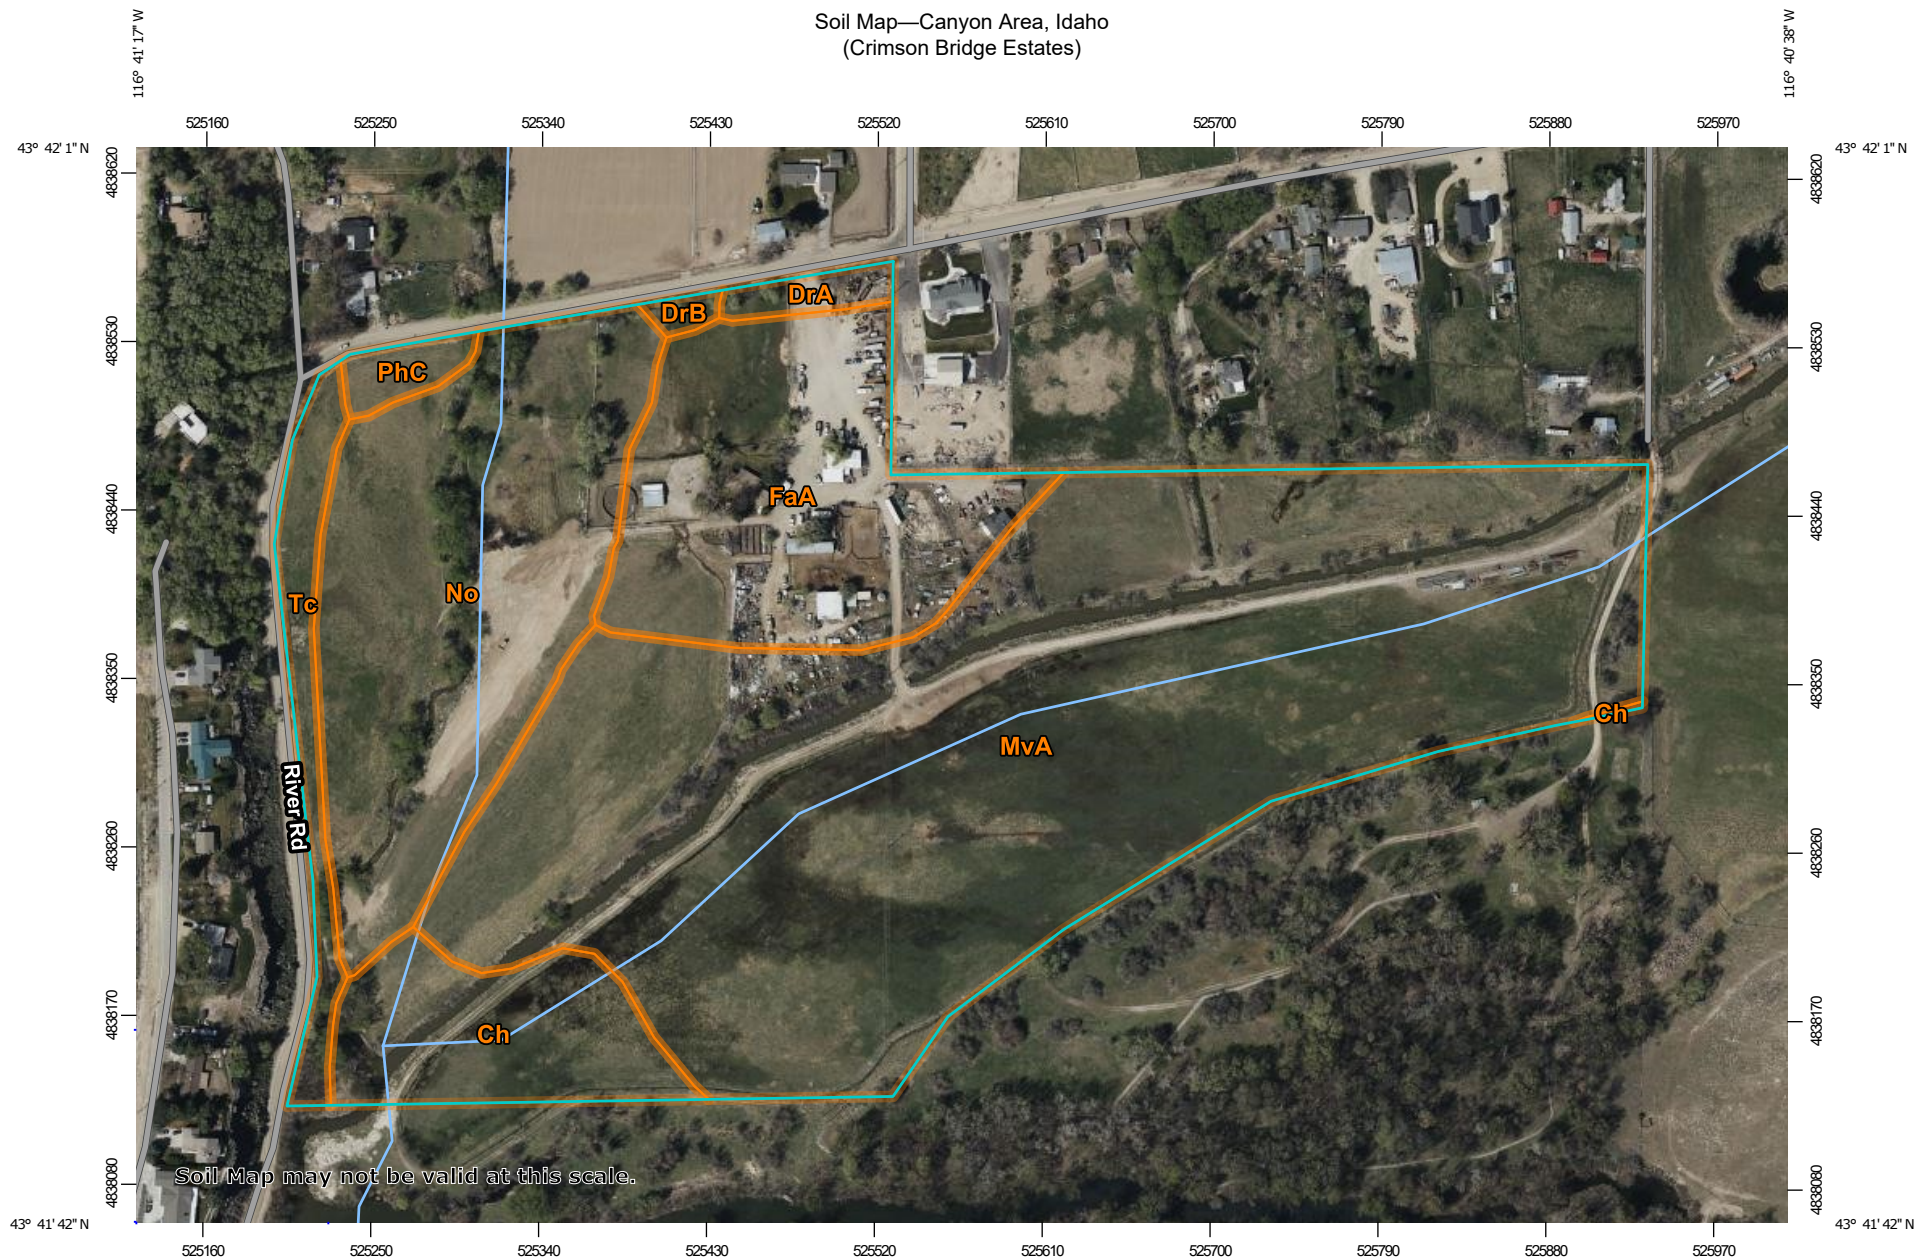
Soil Map—Canyon Area, Idaho (Crimson Bridge Estates)

Map unit symbol	Map unit name	Rating	Acres in AOI	Percent of AOI
Ch	Chance fine sandy loam	90	3.3	6.2%
DrA	Draper loam, 0 to 1 percent slopes	0	0.5	0.8%
DrB	Draper loam, 1 to 3 percent slopes	0	0.2	0.3%
FaA	Falk fine sandy loam, 0 to 2 percent slopes	5	7.3	13.7%
MvA	Moulton loam, 0 to 1 percent slopes	0	30.0	56.6%
No	Notus soils	0	9.7	18.4%
PhC	Power silt loam, 3 to 7 percent slopes	0	0.5	0.9%
Tc	Terrace escarpments	0	1.6	3.0%
Totals for Area of Interest			53.1	100.0%

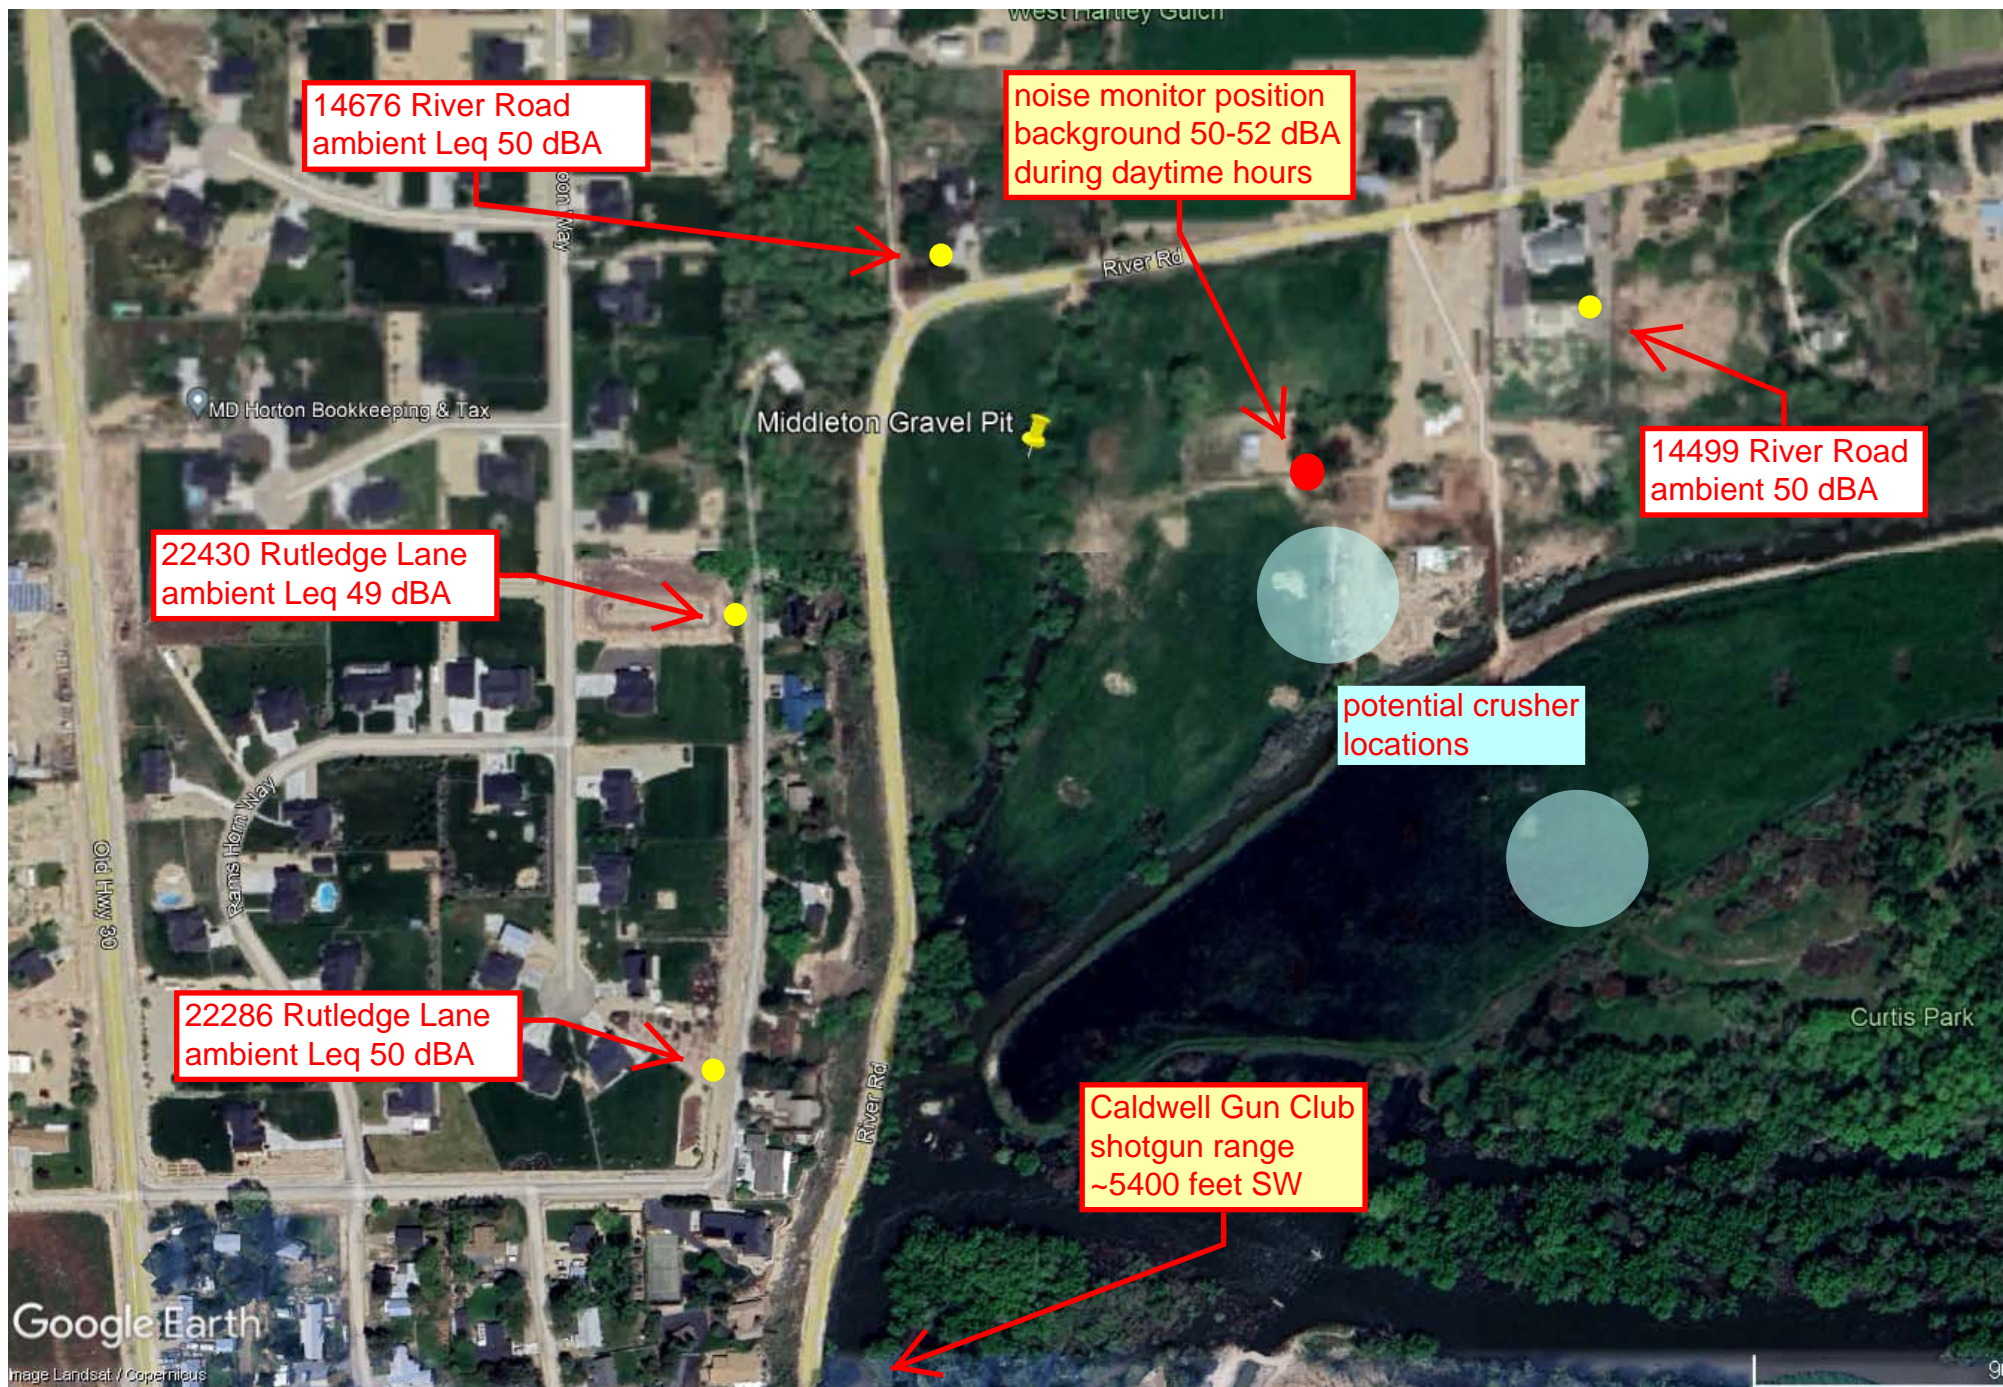
NOISE MEASUREMENT AND ASSESSMENT SITES

24 hour noise monitor
River Road Middleton gravel pit ambient 28-30 MAR 2024

3. **Wetland Delineation Report.** Identifies onsite wetland areas. These will all be avoided based on the site plan.
4. **Noise study.** Concludes that with the recommended mitigation, noise levels generated by the proposal meet the EPA's noise standards.
