From: Michelle Tucker <michelle.tucker@nexus-env.com>
Sent: Monday, April 8, 2024 11:00 AM
To: Michelle Barron
Cc: Carl Anderson; David Stephens
Subject: RE: [External] Crimson Bridge Public Hearing
Attachments: CBE Project Summary aerial 040824.pdf

Crimson Bridge Estates 1954

CRIMSON BRIDGE ESTATES
14533 RIVER ROAD
MIDDLETON, IDAHO

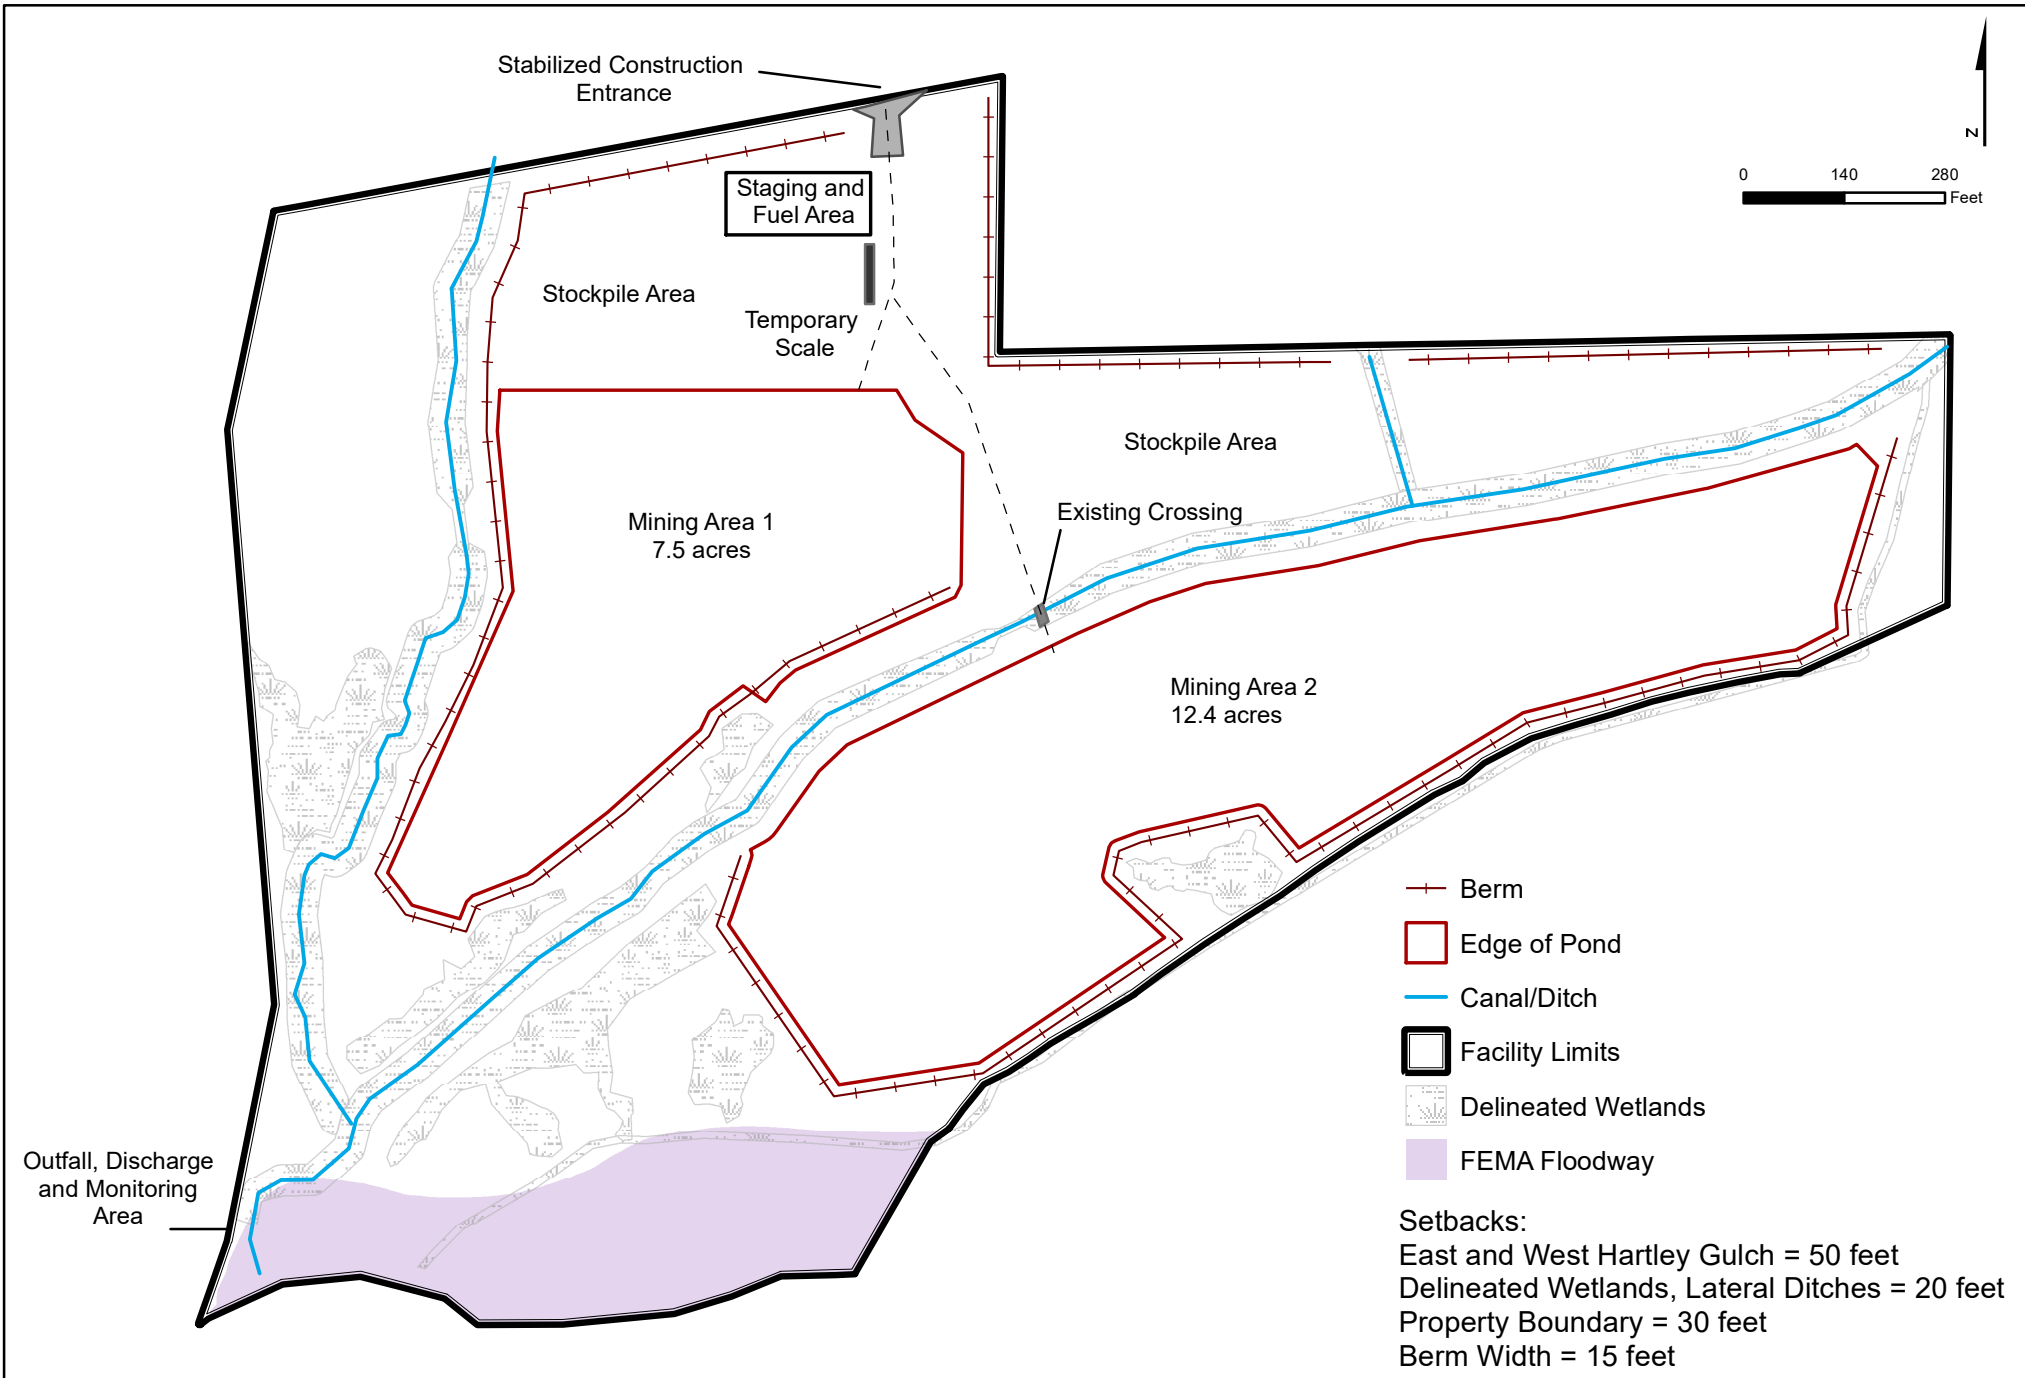
Notes: Temporary settling pond(s) will be constructed as necessary outside of the floodway, and delineated wetlands adjacent to the mining area for de-watering purposes. These temporary ponds will be discharged to one of two drainage ditches under IPDES permit.

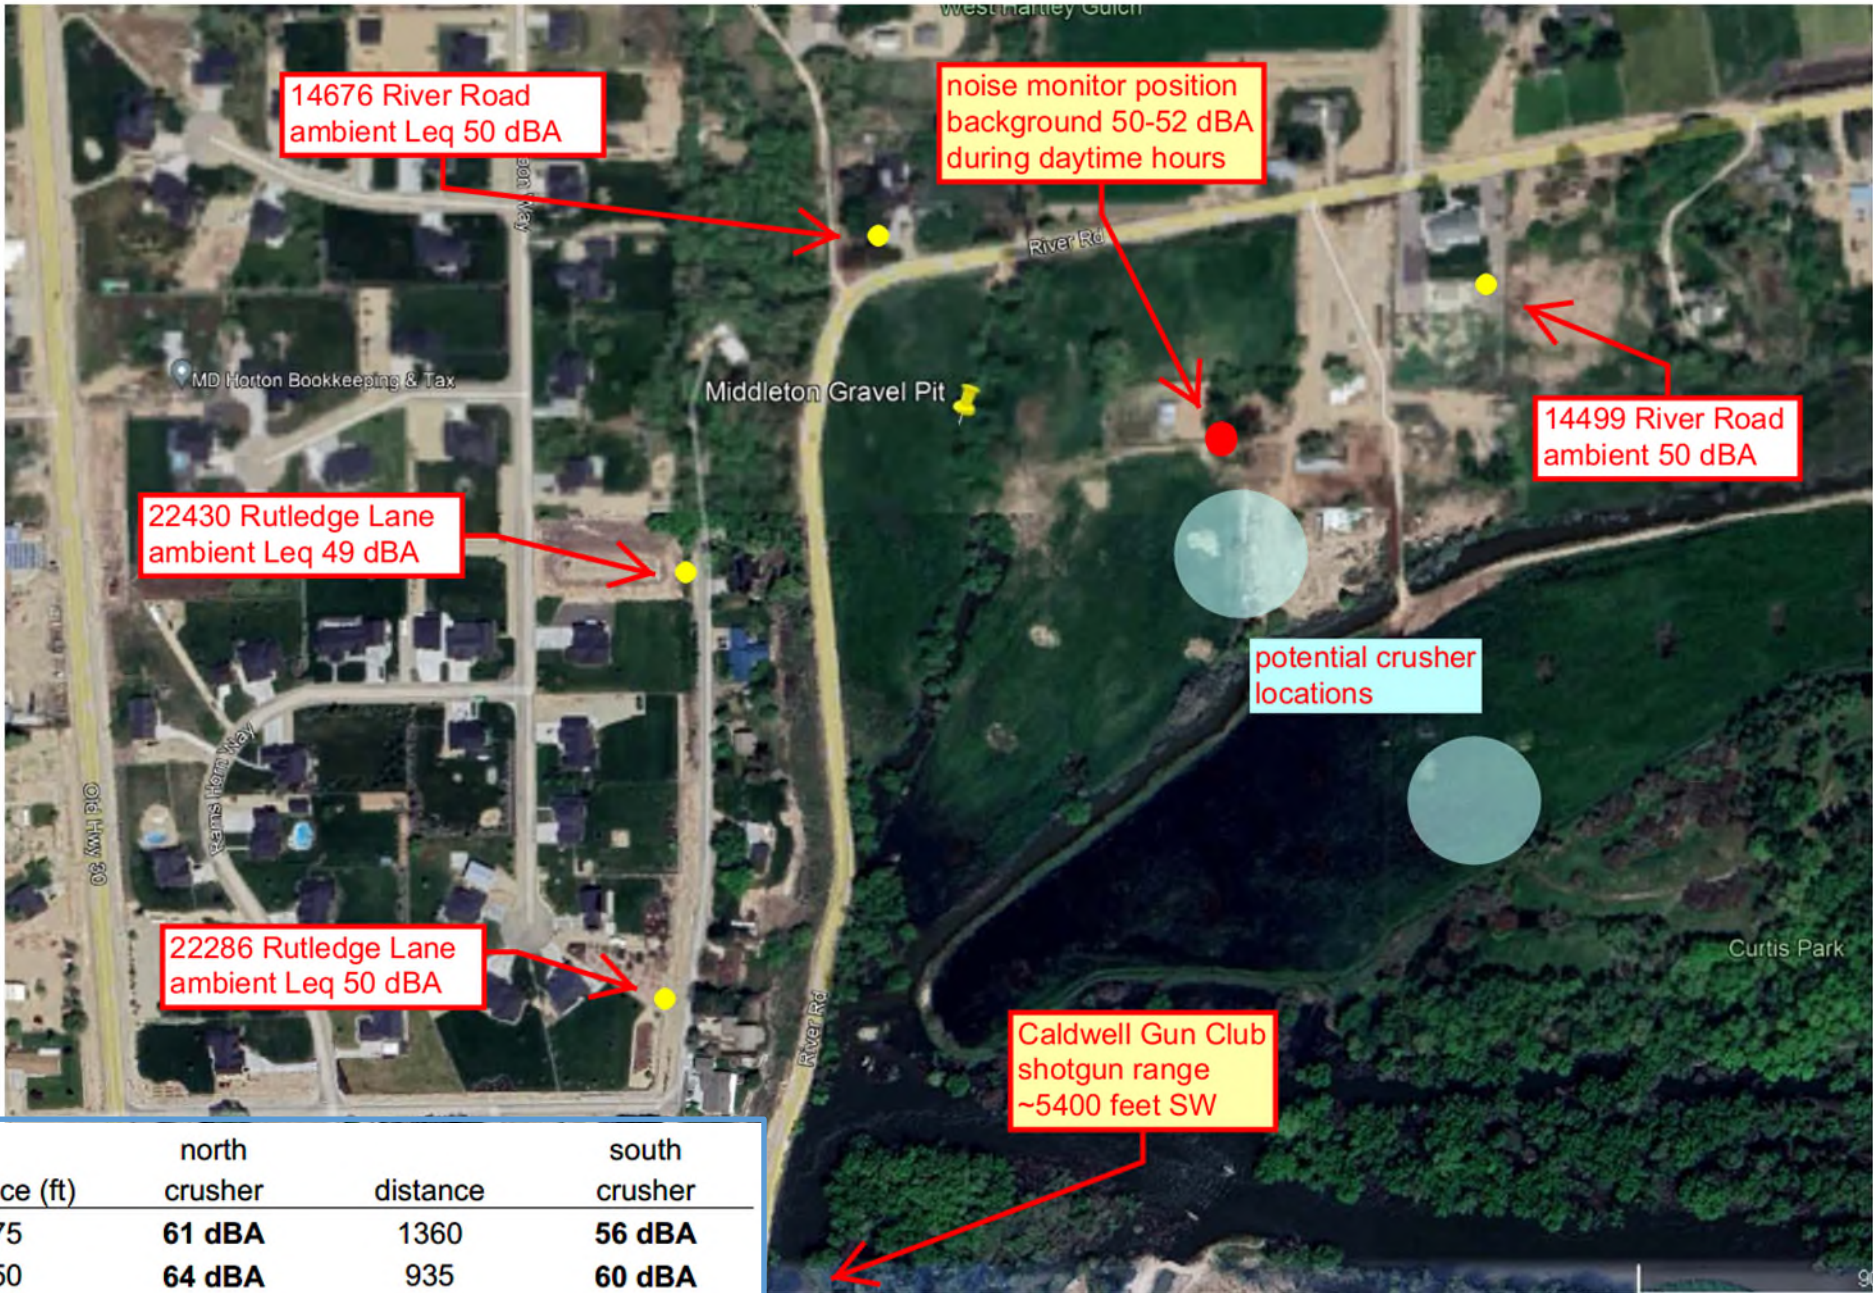
Sound Levels

address	distance (ft)	north crusher	distance	south crusher
14676 River Road	775	61 dBA	1360	56 dBA
14499 River Road*	550	64 dBA	935	60 dBA
22430 Rutledge Lane	790	61 dBA	1230	57 dBA

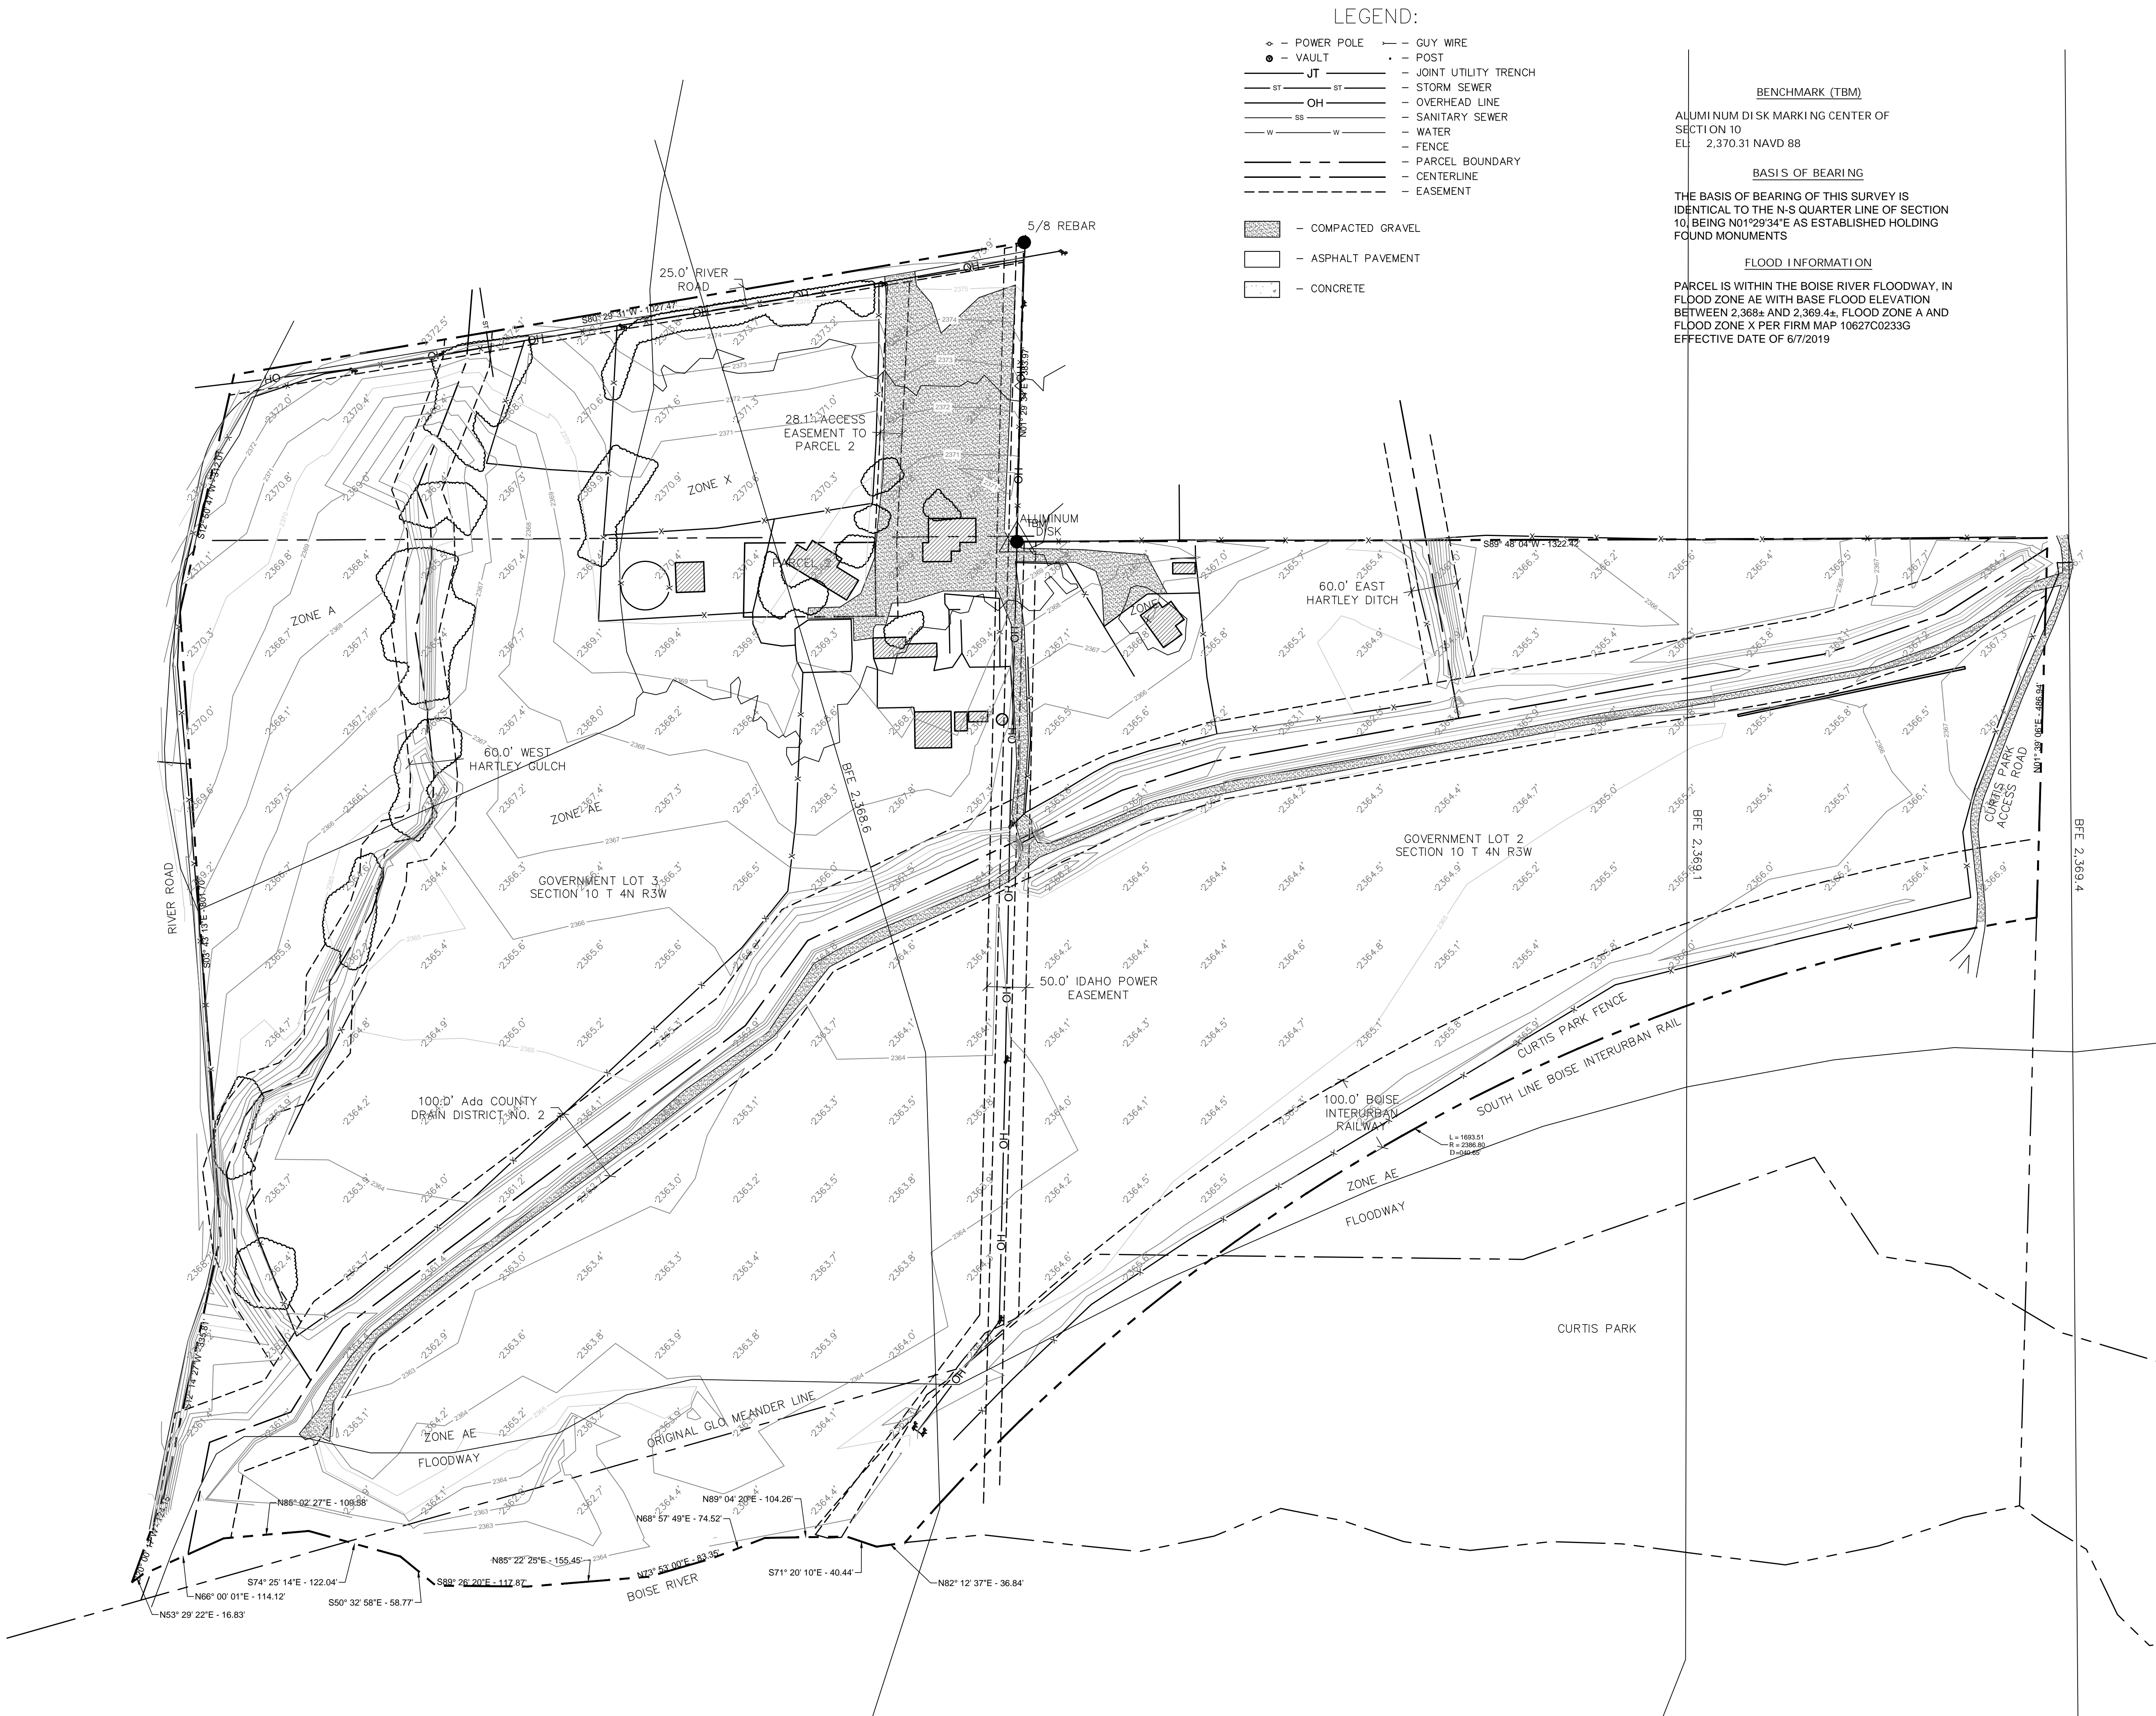
FLOOD INFORMATION
PARCEL IS WITHIN THE BOISE RIVER FLOODWAY, IN FLOOD ZONE AE WITH BASE FLOOD ELEVATION BETWEEN 2,368± AND 2,369.4±. FLOOD ZONE A AND FLOOD ZONE X PER FIRM MAP 10627C0233G EFFECTIVE DATE OF 6/7/2019
